NEW YORK STATE SUPERFUND CONTRACT

PRELIMINARY AGREEMENT
(SITE INVESTIGATION)
REPORT

New Cassel Industrial Area Site
North Hempstead, Nassau County

Site No. 130043

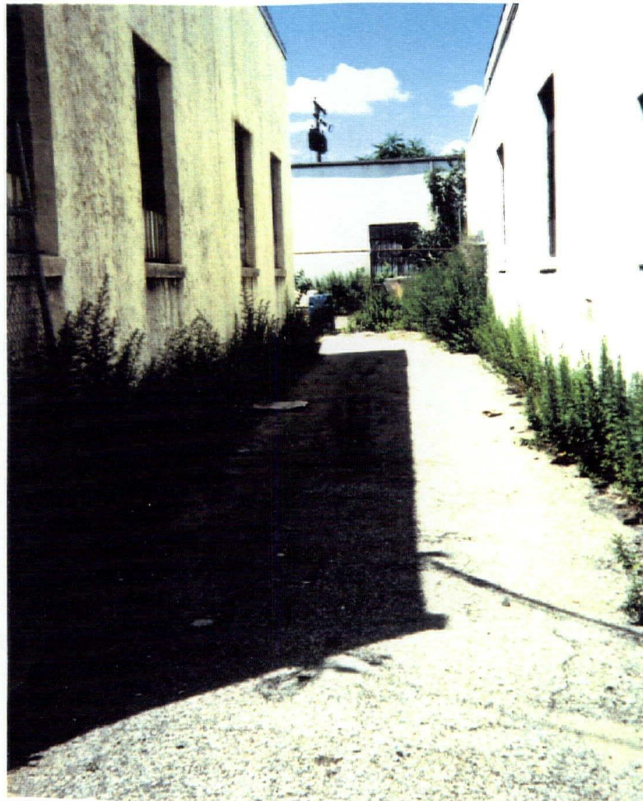
PHOTO 29. 81 Garden Street (tax block 70, lots 40-42), looking west along alley between 81 and 87-89 Garden Street.

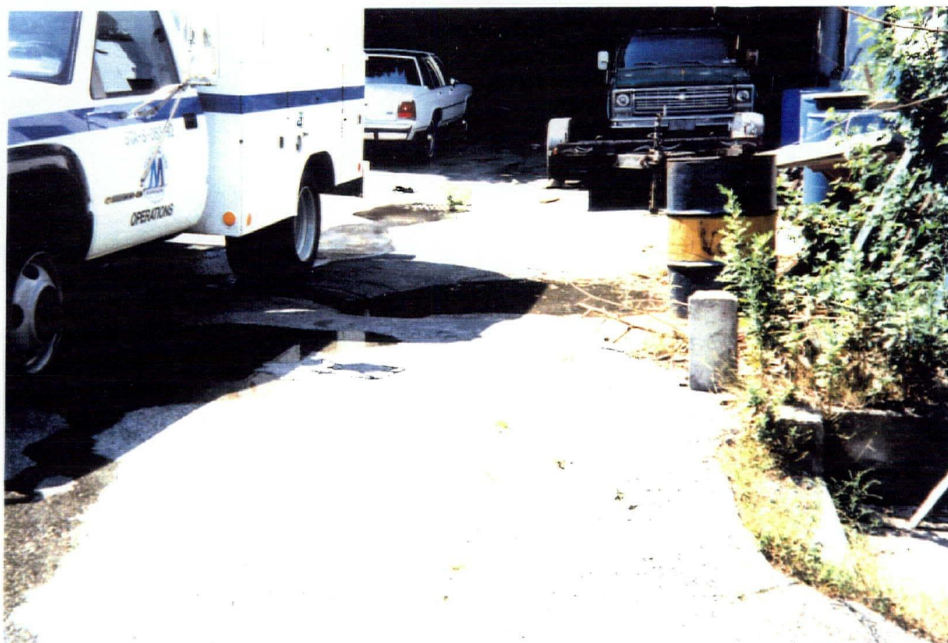
PHOTO 30. Rear of Alltec, Inc., at 80-86 Magnolia Avenue (tax block 70, lots 16-17,54-55). Note suspected leachpool.
